In-mill examples show how such problems as sheet breaks, coupling problems, and machine drive instability can sometimes be reduced with more in-depth analysis

Online Torque Monitoring System Reveals Unexpected Causes of Machine Problems

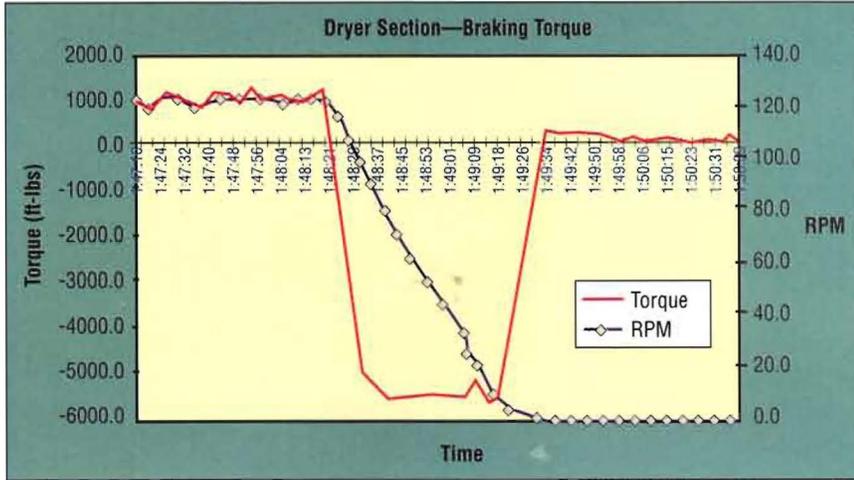
The higher than expected torque readings can have multiple causes. Common torque-consuming situations include sleeved bearings on the dryers, condensate buildup, high felt pressures, and worn bearings. Additionally, aggressive acceleration and deceleration rates can create high torque demands that can adversely affect equipment performance and life (Figure 2).

FIGURE 2: Aggressive acceleration and deceleration rates can create high torque demands that adversely affect equipment performance.

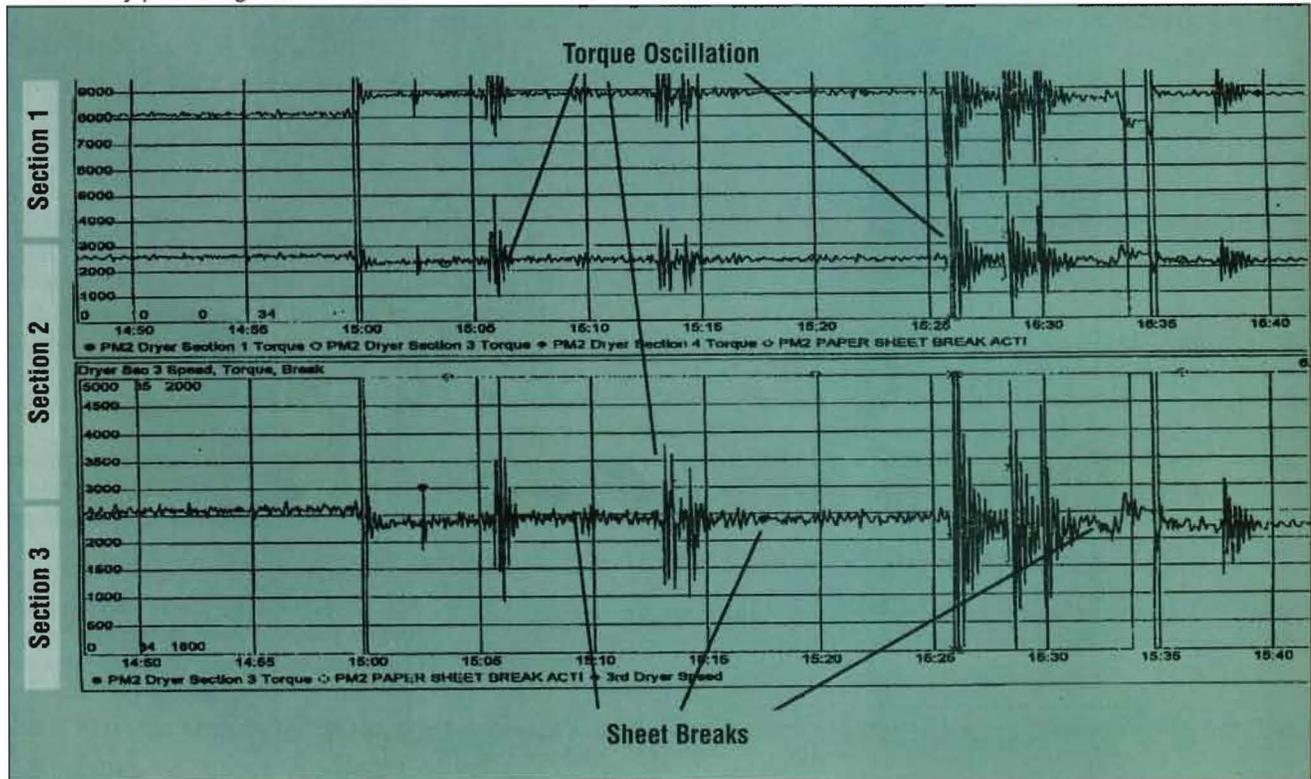
FIGURE 3: In one case study, torque measurement showed that all three dryer sections experienced oscillations immediately preceding a sheet break.

The paper machine trims at 240 in., operates at up to 2,400 fpm, and is turbine driven through a lineshaft and cone pulley arrangement. The information from torque measurement showed that the three dryer sections experience significant torque oscillations immediately preceding a sheet break (Figure 3).

Comparing data from the three sections, the torque oscillations occurred simultaneously in all three sections. Since it is highly unlikely that all three sections experienced condensate loading at exactly the same moment, this was eliminated as a cause (in these

Upon investigation, it was uncovered that the pneumatic controller for the turbine governor had not been tuned correctly. Consequently, whenever a speed change was attempted, the governor "hunted," which resulted in varying turbine output. This caused oscillations of the paper machine drive torque which showed up on the torque monitor. These oscillations were severe enough to cause sheet breaks.

Since this discovery, the governor controller has been properly tuned, and sheet breaks during speed changes have been reduced to normal levels. However, there is still a higher than normal number of sheet breaks in the dryer sections during normal operating conditions. As Figure 4 shows, the machine is still experiencing cyclic torque oscillation spikes every 3 to 30 minutes. The cause of this is still being investigated but it is thought that problems with the condensate system—resulting in temporary water buildup in the dryers—could be a factor. Additionally, changes in steam value and/or turbine output could be possible causes.

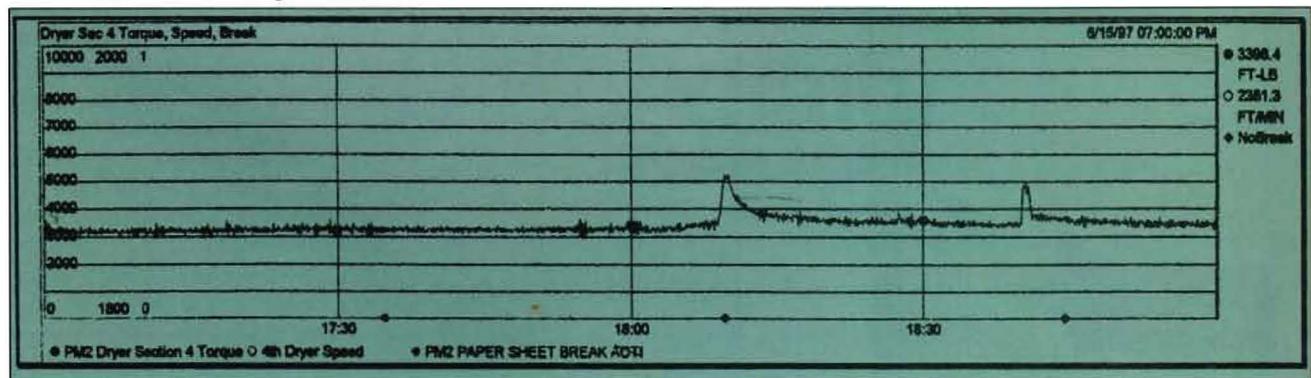
FIGURE 4: Based on torque measurements, this machine continues to experience cyclic torque oscillation spikes, which is still to be investigated.

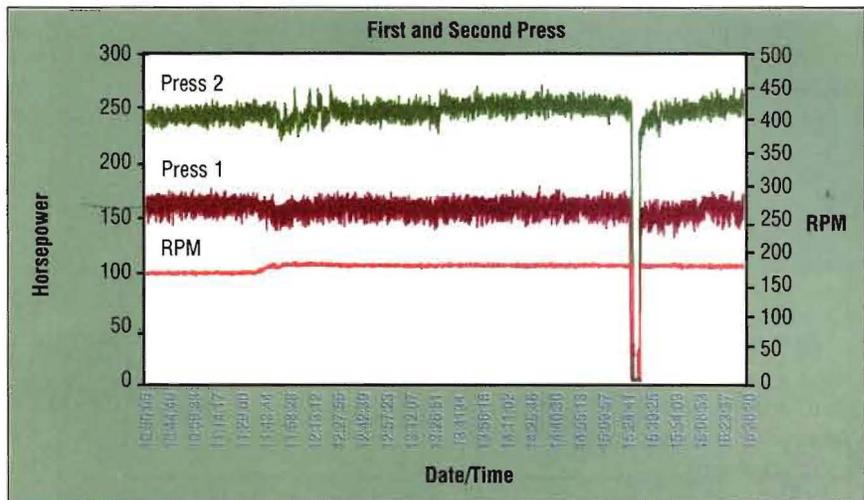
Upon measurement, and contrary to what was expected, the torque level in the second press was 66% higher than the first press (Figure 5). However, that level did not exceed the capacity rating of the coupling. The question, then, was what could be causing the first press coupling breakage?

The first and second press share a common fabric. The measurements shown in Figure 5 indicate the second press torque may be pulling the first press, creating an overdrive condition at the coupling. In this situation, the first

FIGURE 5: On this machine, second press torque is higher than the first press, indicating that the second press may be pulling the first press.

press drive motor was holding the first press roll back against the drive from the second press, which is transmitted through the shared fabric. Although the torque level on the first press in-drive shaft was not excessive, the overdrive can produce conditions detrimental to coupling life.

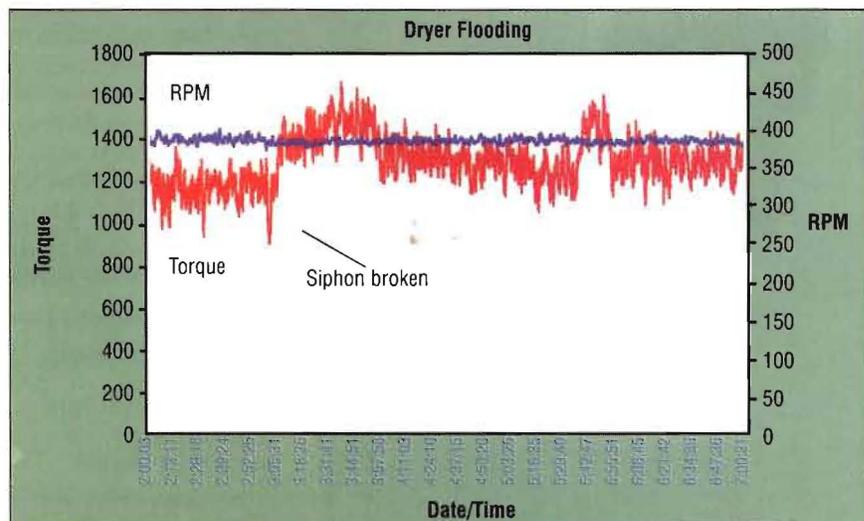
FIGURE 6: Torque measurements helped one mill determine that the torque increase coincided with a siphon break and subsequent flooding of one of the dryers.

Interestingly, during analysis of the data, it was discovered that at 3:05:31, the torque began to climb, and by 3:45:53 had increased 40%. After that, the torque decreased slightly but remained at levels of 25% to 42% higher than previous operating levels. The mill then compared this data to the log of machine events and determined that the torque increase coincided with a siphon breakage, and subsequent flooding, of one of the dryers (Figure 6).
