SPINNAKER CORPORATION

Subject: Short inspection of Yankee to coater rope system

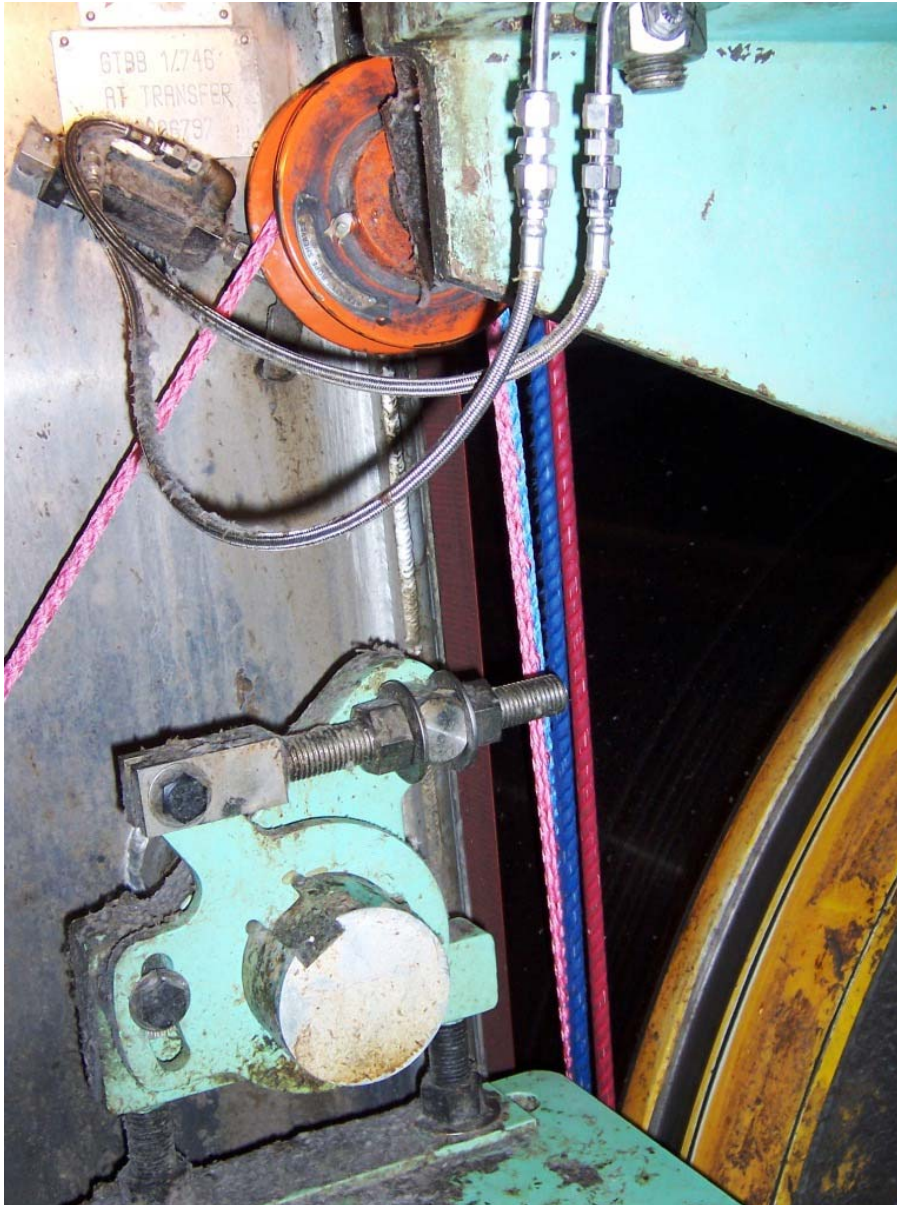
Picture #: 1

1. At the tail transfer from the first section dryers (pic. 1) to the basement dryers, the ropes of the two sections run together for approximately three feet. This may create frictional abrasion depending on amount of draw (speed differential) between the two sections.

Location: Rope transfer 1st to basement dryers

Comments: Considerable contact of ropes between sections.

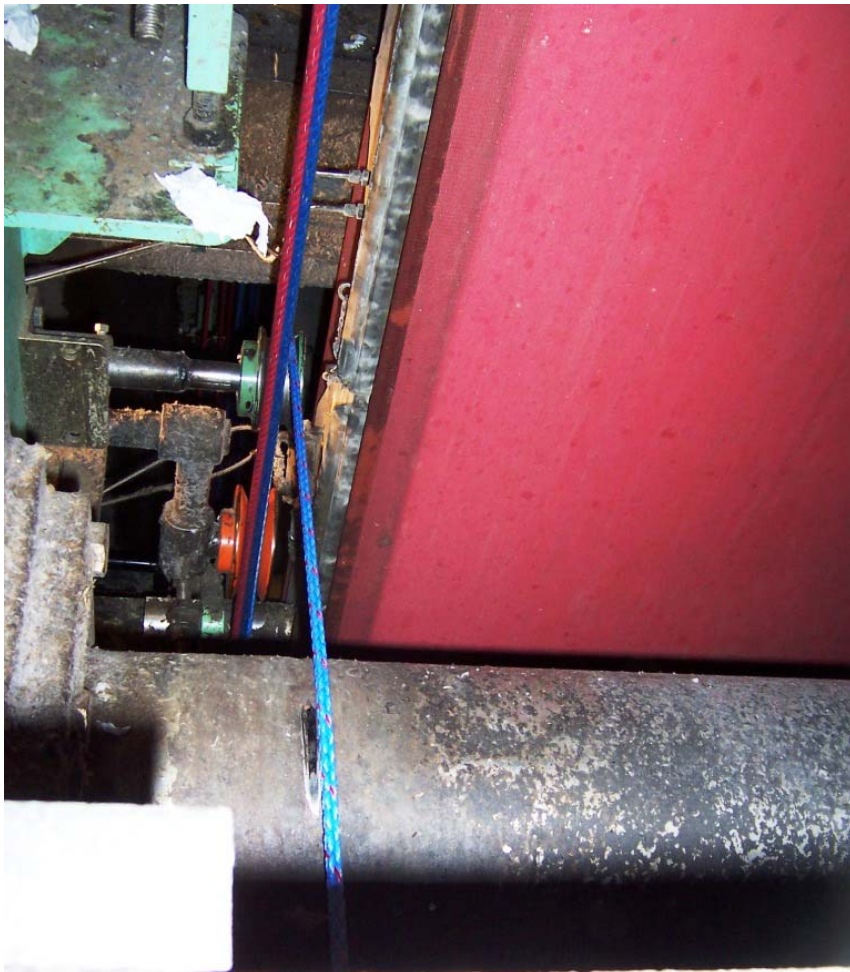
Picture #: 2

2. On the return run of the blue rope in the basement dryers it drags across a frame spacer (pic. 2). The millwrights were instructed to move the rope pulley closer to the column to improve the angle to the next pulley such that the rope clears the frame spacer (pic. 3).

Location: Basement dryers; blue rope return

Comments: Rope dragging across frame spacer

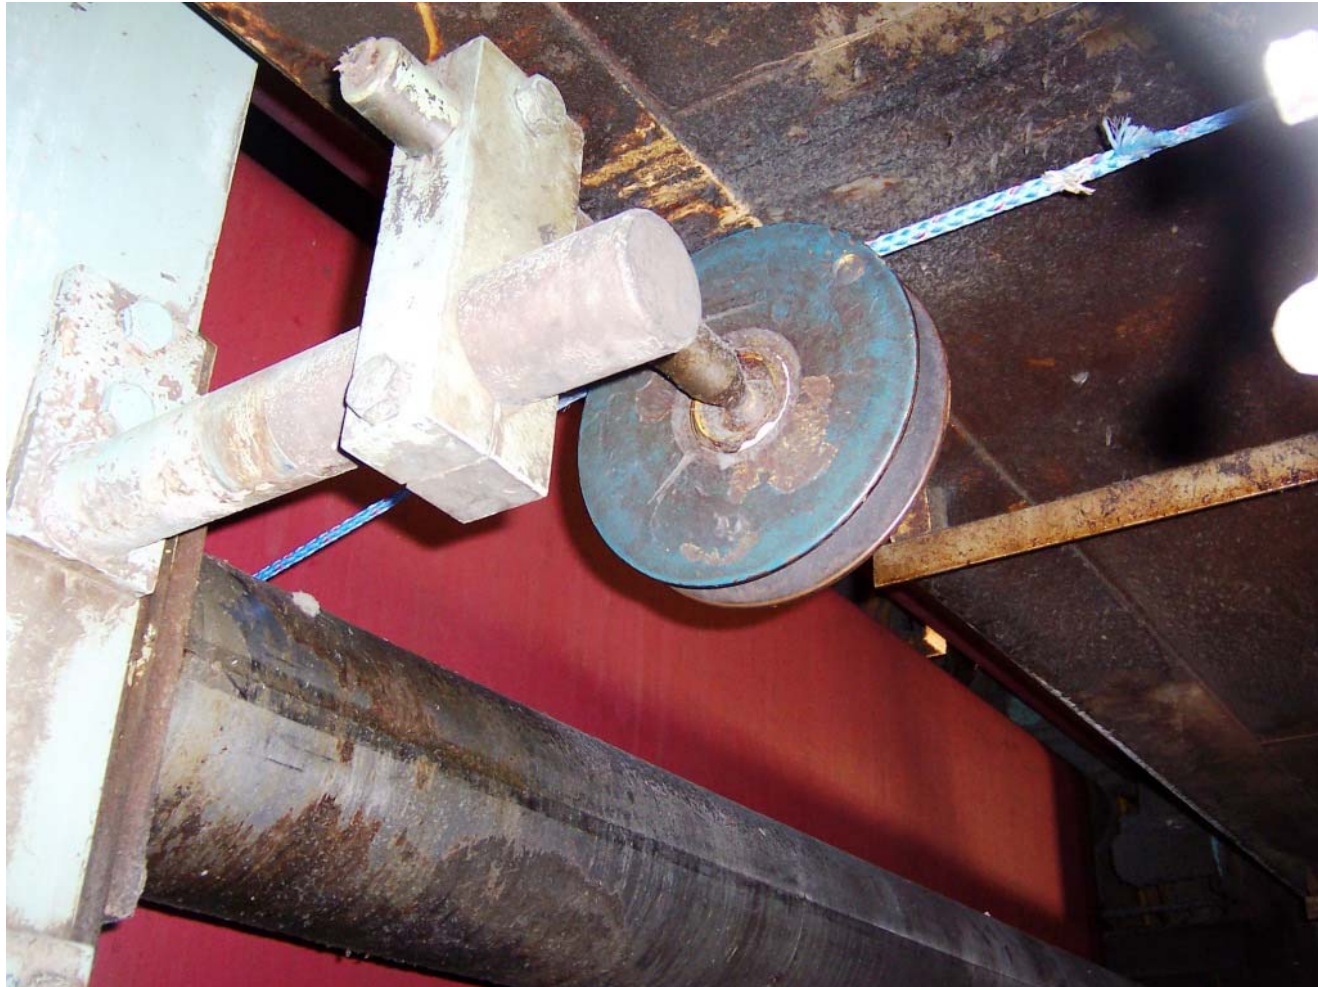
Picture #: 3

Location: Basement dryers; blue rope return

Comments: Move closer to support column to improve lead over frame spacer.

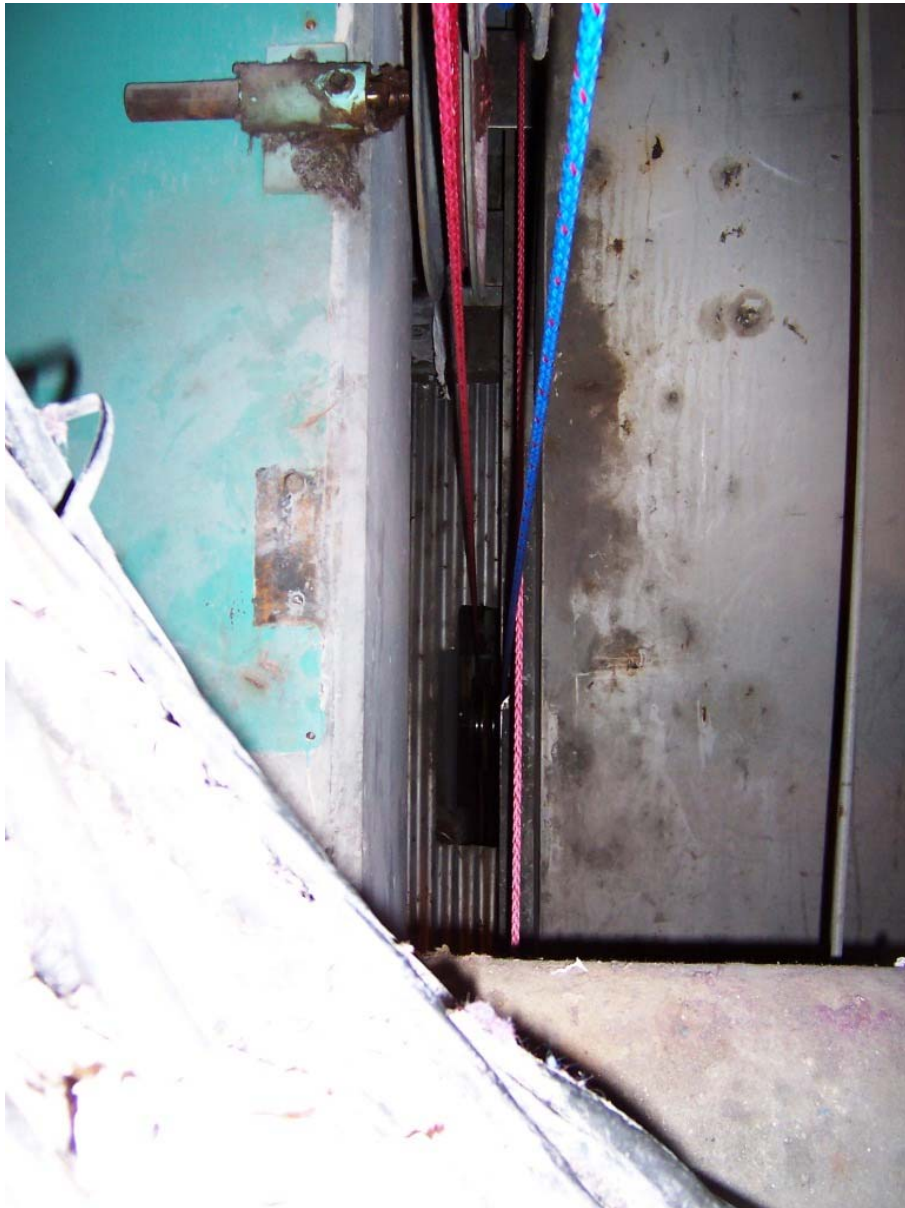
Picture #: 4

3. The blue rope drags across the pulper side frame in basement on its return run from the stretcher to the basement dryers (pic. 4). It appears that, at one time, there was a double rope pulley mounted to the column adjacent to the pulper that was intended as the rope path and this would have cleared the pulper. It was mentioned that this pulley was removed due to problems with the ropes jumping off the pulley and running in the space between the double pulleys. This however, may have been the result of incorrect rope threading. As a temporary correction, the millwrights instructed to re-position the blue rope pulley near the dry end of the basement dryers to move the blue rope away from the pulper side.

Location: Yankee pulper

Comments: Rope dragging on pulper.

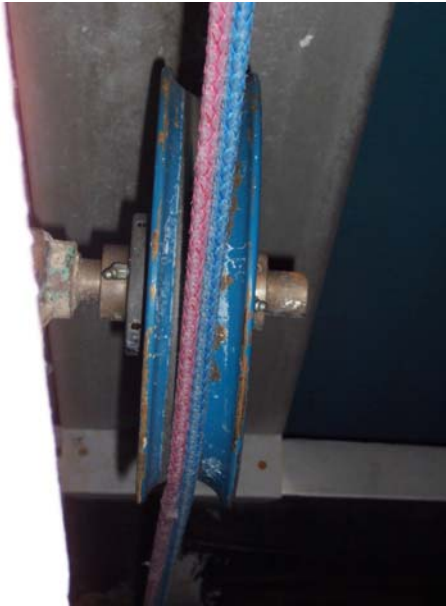
Picture #: 9

Location: Floor level; lead to Mt. Hope

Comments: No problems.

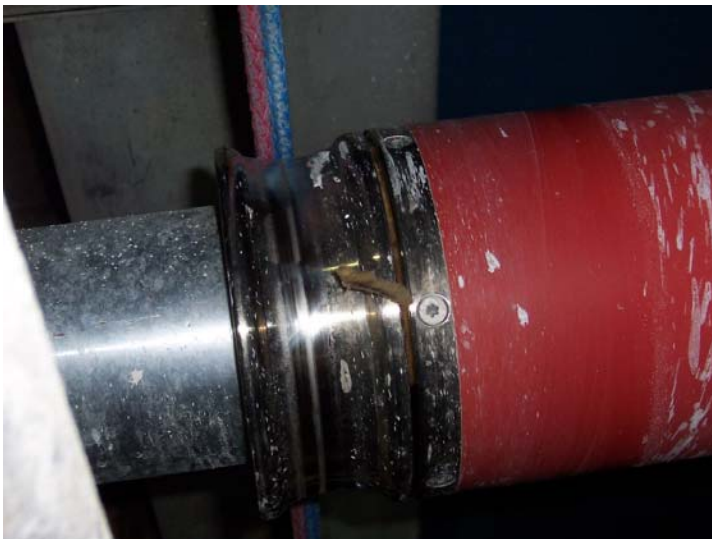
Picture #: 10

Location: Mt. Hope prior to dryers

Alignment: Shifted to D.S.

Comments: Rope running on T.S. side of groove.

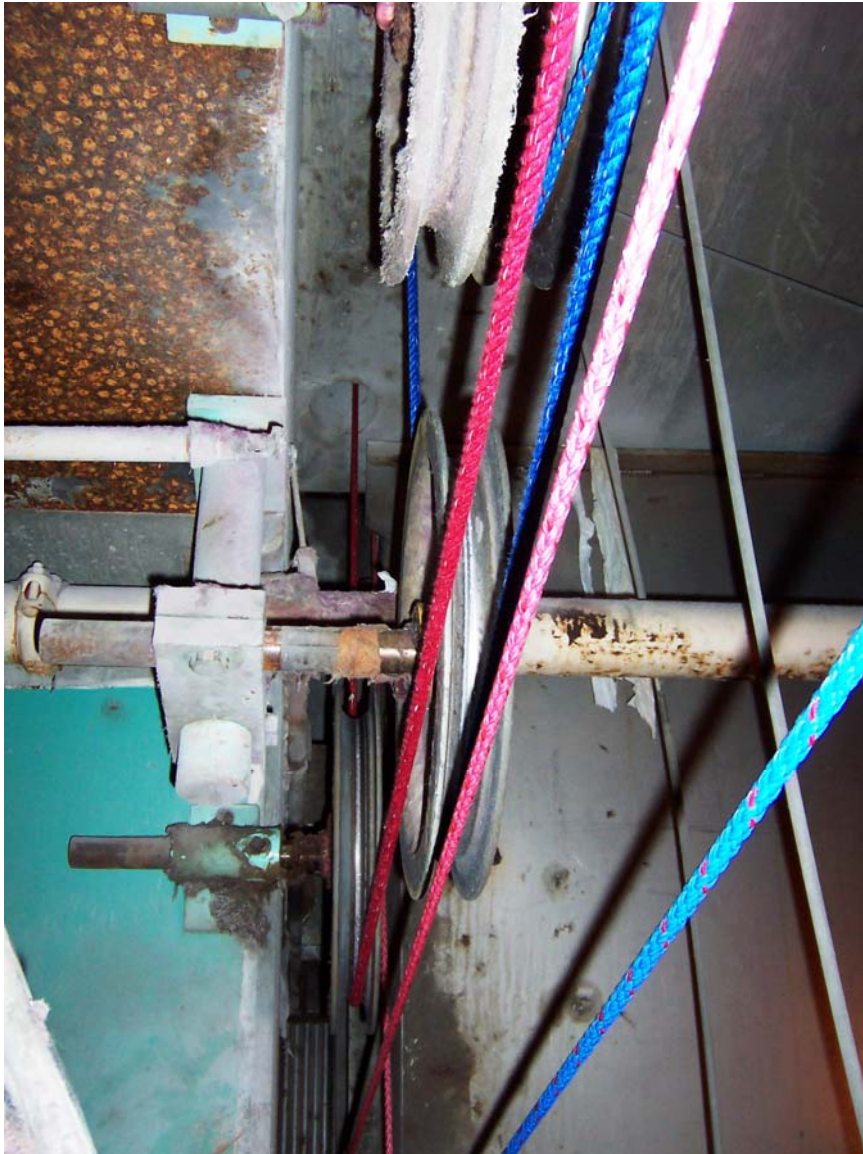
Picture #: 5

4. The red & blue ropes cross each other in the basement run from the pull stack to the stretcher (pic. 5). This can be corrected by switching the single blue rope pulley under the pull stack with the double blue rope pulley used for the blue rope in the first coater section, as this is now used only as a single pulley (pic. 6). The blue rope from the pull stack would then be routed to the outside groove of the double pulley with the red rope on the inside.

Location: Under pull stack.

Comments: Ropes crossing each other.

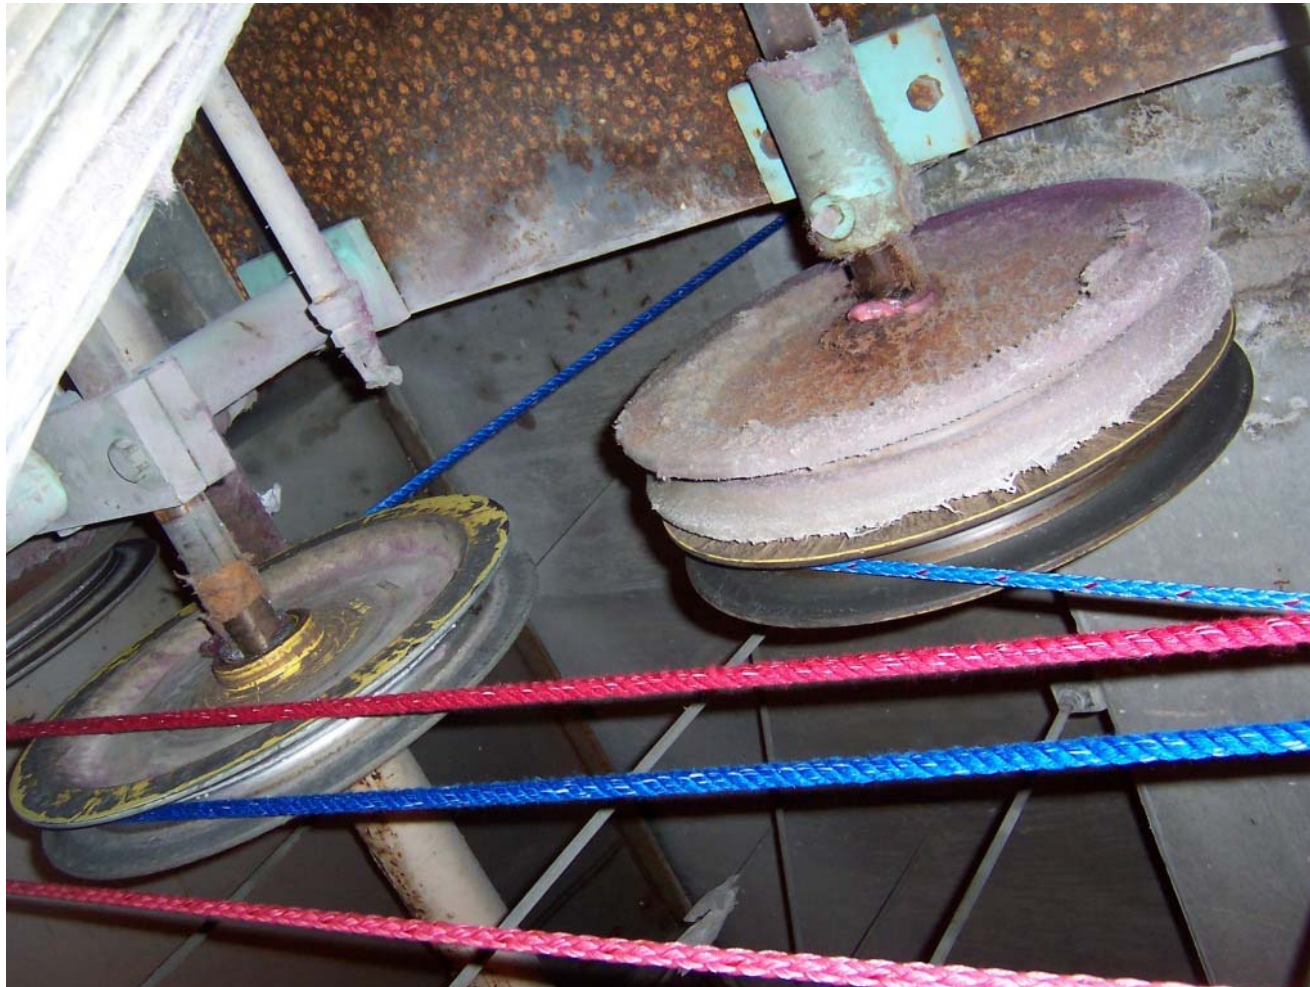
- Picture #: 6
- Location: Under pull stack.
- Bearing: N/A
- Alignment: N/A
- Comments: Pulleys can be swapped to eliminate ropes crossing.

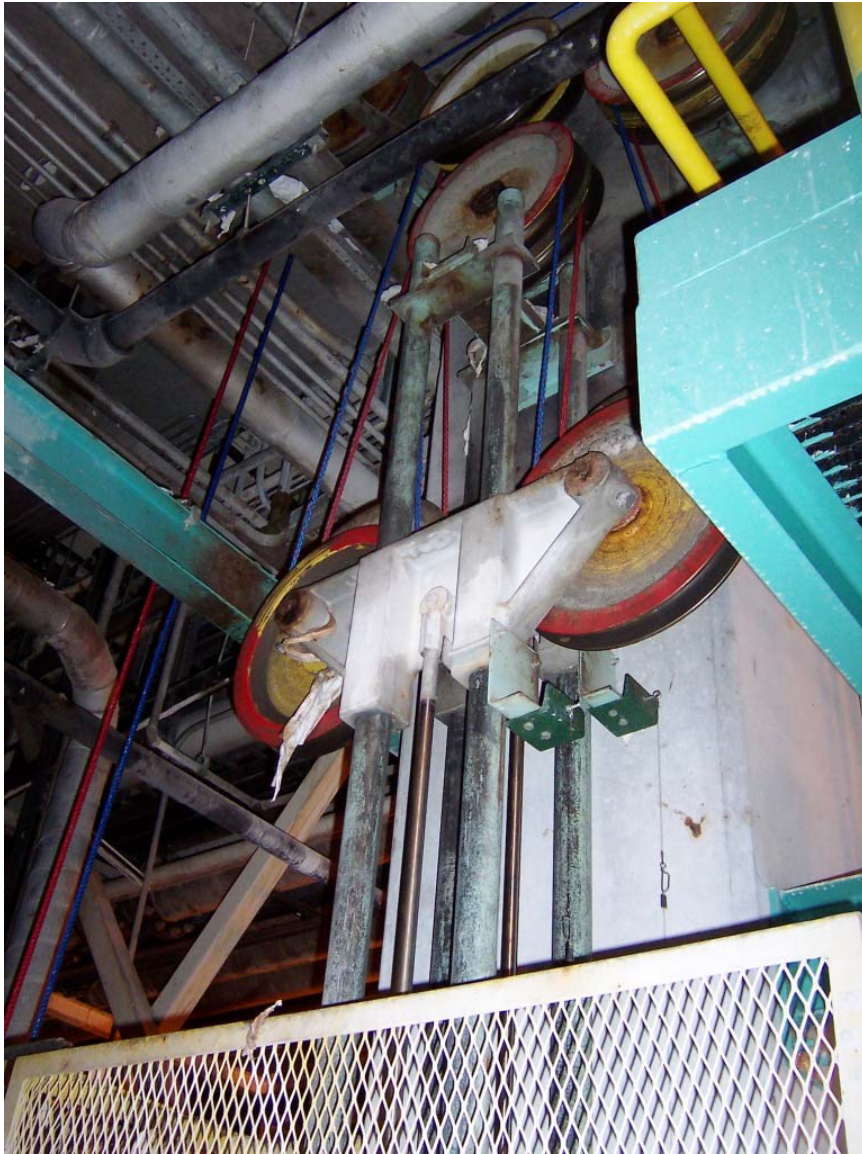
Picture #: 7

5. The stretchers are older, less efficient designs with considerable hysteresis (pic. 7). Rope life can be improved by replacing with a newer unit that includes “Thread” and “Run” modes. In “Run” mode the rope tension is reduced to the minimum to keep the ropes on the pulleys. On a sheet break, the system automatically switches to a higher rope tension (“Thread”) for tailing. Running in the lower rope tension except for tailing reduces rope stress and increases rope life.

Location: Rope stretcher.

Comments: Older, less efficient rope stretcher.
